Fall of a spinner

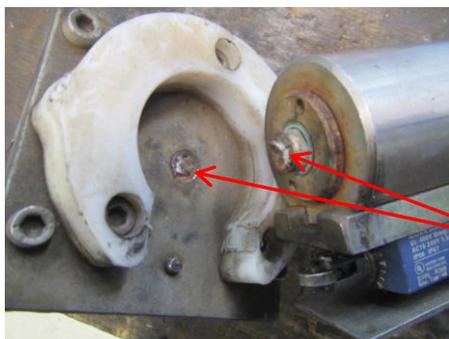
**Rupture
due to
corrosion**

On a cleaning bay suddenly a spinner of ca. 60 kg fell down and hit the arm of the cleaning operator causing a serious bruise. He was lucky that the spinner did not fall on his head! This could have killed him !!!

The suspension of the 200 bar spinner was provided with a load cell to avoid the spinner to start without being put in a manhole. A bolt in the load cell, not visible from the outside, broke suddenly due to internal corrosion.

Load cell internally broken

Load cell rebuilt with additional suspension

- Check the suspension of all spinners regularly!
- Secure all single suspensions with an additional safety suspension.
- Include in your maintenance program the dismantling of all single suspensions and check them for corrosion or other defects regularly.
